Case History

Background

Photo-Cat Destruction Performance

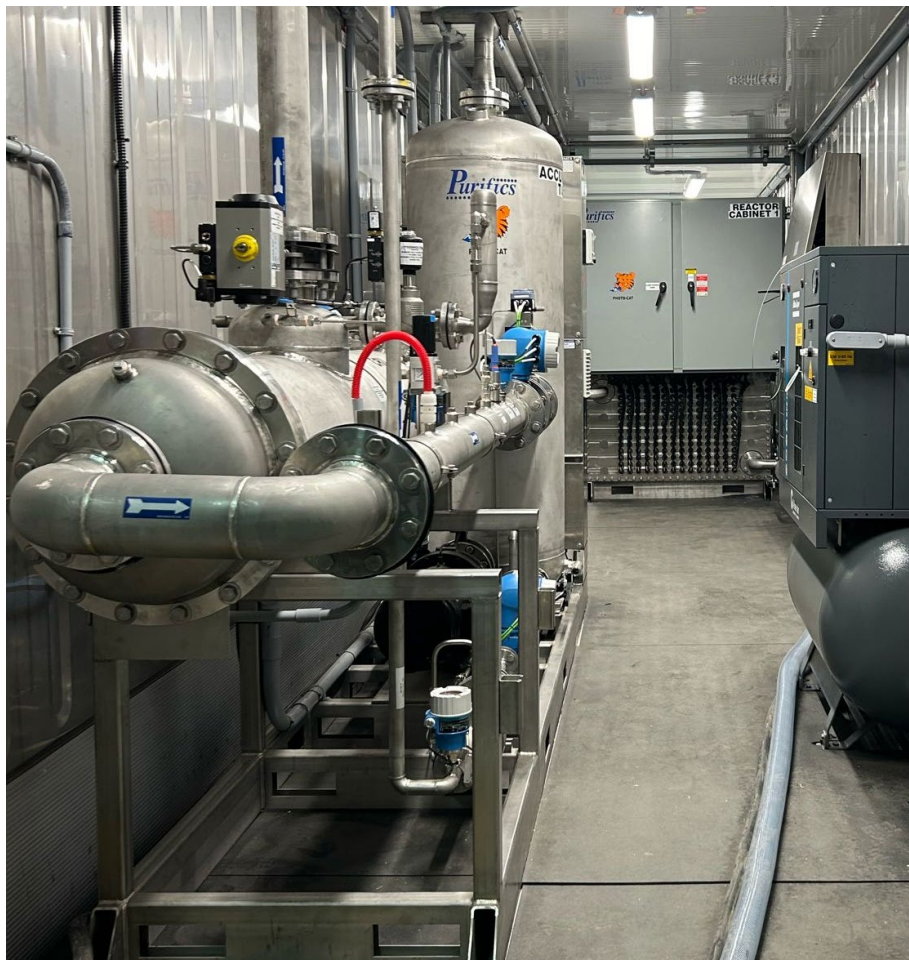
A packaged Photo-Cat system for ground water purification is shown below for compounds such as 1,4-Dioxane, 1,1-DCE, cVOCs and PFAS.
